"Full" Reserve Study

Locksley Woods COA Greenville, NC

**Report #: 32686-0
For Period Beginning: January 1, 2018
Expires: December 31, 2018**

Date Prepared: September 11, 2017

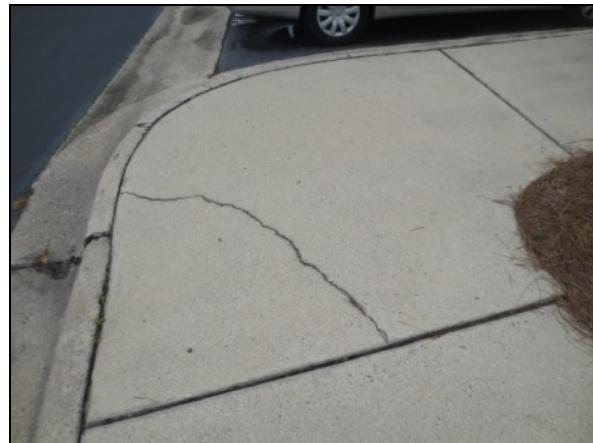
Comp #: 2107 Concrete Sidewalks - Repair

Evaluation: Some minor cracks noticed. Repair any trip and fall hazards immediately to ensure safety. As routine maintenance, inspect regularly, pressure wash for appearance and repair promptly as needed to prevent water penetrating into the base and causing further damage. In our experience, larger repair/replacement expenses may emerge as the community ages. At this time, no recommendation for Reserve funding, but this component should be re-evaluated during future Reserve Study updates based on conditions at that time.

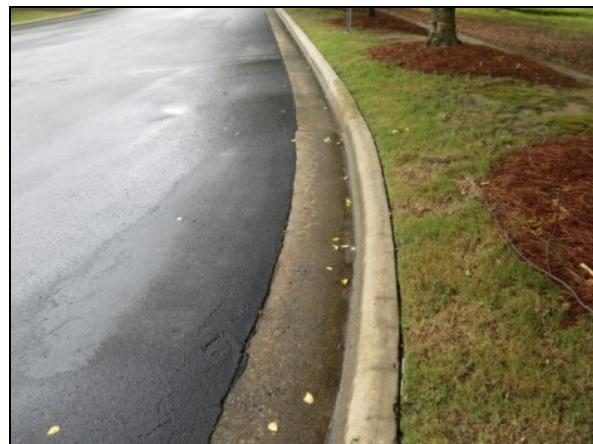
Comp #: 2109 Concrete Curbs & Gutters - Repair

Evaluation: Again, normal cracking and minor breakage was noticed. Curbs and gutters are typically not life-limited components and can often be repaired as needed for relatively low cost using Operating funds. If potholes, large cracks, or other drainage impediments develop, these should be addressed to ensure proper water flow. No need for Reserve funding at this time. If cost become more consistent then reserve funding should be added.

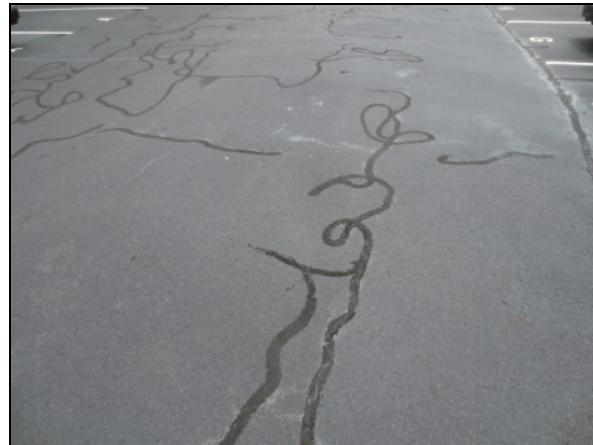
Evaluation: Large repairs and minor replacement projects were noticed. As routine maintenance, keep roadway clean, free of debris and well drained; fill/seal cracks to prevent water from penetrating into the sub-base and accelerating damage. Even with ordinary care and maintenance, plan for eventual large scale resurface (milling and overlay of all asphalt surfaces is recommended here, unless otherwise noted) at roughly the time frame below. Take note of any areas of ponding water or other drainage concerns, and incorporate repairs into scope of work for resurfacing. Our inspection is visual only and does not incorporate any core sampling or other testing, which may be advisable when asphalt is nearing end of useful life. Some communities choose to work with independent paving consultants or engineering firms in order to identify any hidden concerns and develop scope of work prior to bidding. If more comprehensive analysis becomes available, incorporate findings into future Reserve Study updates as appropriate.

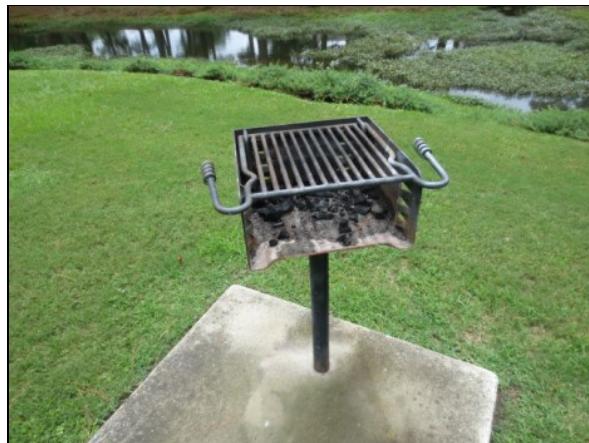
Evaluation: Surface wear was noticed. Some grills appeared to be older. Barbecues were not tested during site inspection, and are assumed to be functional. It was reported that these grills are being removed systematically and not being replaced due to the low use. No reserve funding required. Should be cleaned after each use and covered when not in use in order to prolong life expectancy. Removal costs should be handled as an operating expense.

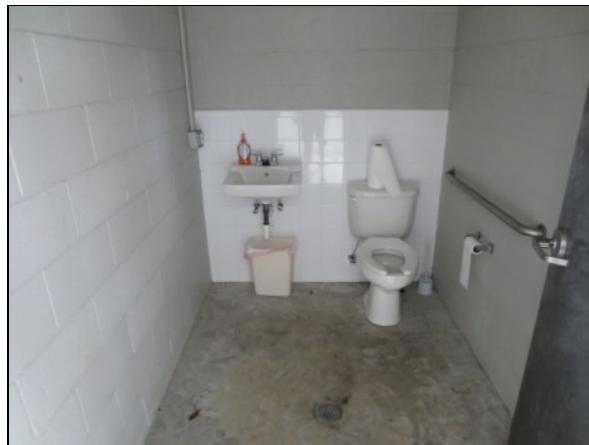
Evaluation: Minor surface wear was noticed. Bathrooms are older and simple. As routine maintenance, inspect regularly and perform any needed repairs promptly utilizing general Operating funds. Typical remodeling project can include some or all of the following: replacement of plumbing fixtures, partitions, countertops, lighting, flooring, ventilation fans, accessories, décor, etc. Costs can vary greatly depending on scope of work involved. In general, estimates shown are based primarily on cosmetic remodeling, not necessarily total "gut" remodel projects unless otherwise noted.

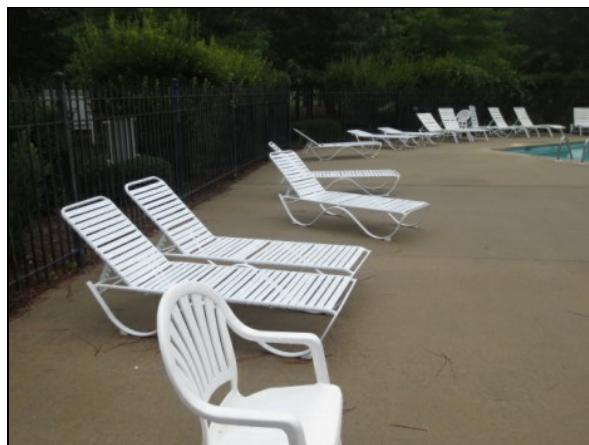
Evaluation: Surface wear was noticed along with staining on most surfaces. (22) lounge chairs and (15) chairs counted during inspection. We recommend regular inspections and repair or replacement of any damaged pieces promptly to ensure safety. Protected storage of furniture when not in use can help to extend useful life. Best practice is to replace all pieces together in order to maintain consistent style and quality in the pool/recreation area. Costs can vary greatly based on type of pieces selected for replacement. Funding recommendation shown here is based on replacement with comparable number and quality of pieces.

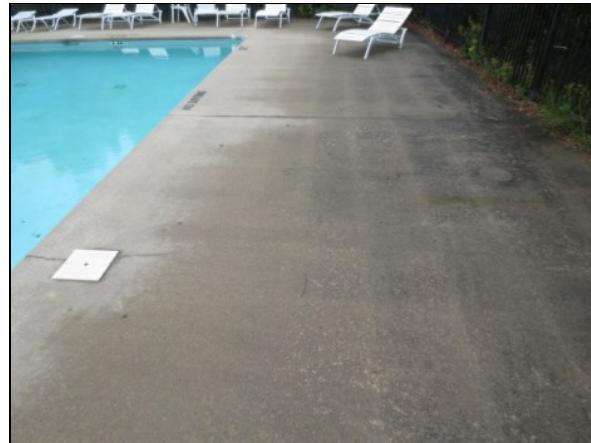
Evaluation: Breakage and cracking were noticed in isolated areas. Significant cracking was noticed near the stairs leading into the pool. Concrete pool decks should have a long useful life under normal circumstances. Should be pressure-washed as needed to preserve appearance and remove stains, chemical residue, etc. Replacement costs can vary depending on style of concrete chosen, configuration of deck, etc. We recommend budgeting for replacement at the approximate interval shown here. Normally these deck need a one time larger project. Scope is hard to define but we are funding for a 15% replacement project.

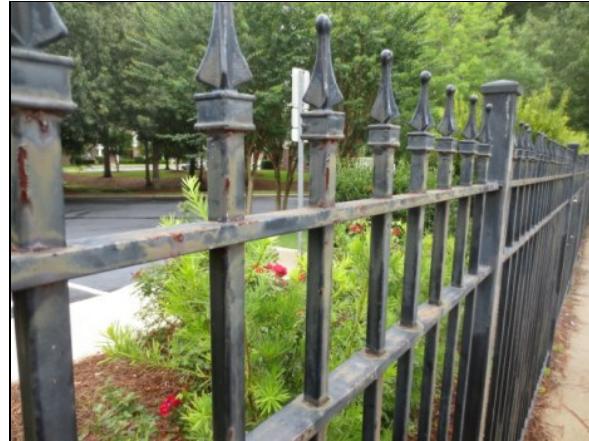
Evaluation: Fence appeared to be a iron fence which should have a long useful life. Repainting project should occur to rejuvenate fence and help the fence extend its remaining useful life. Rusting was noticed in areas. As a routine maintenance item, fence should be inspected regularly and repaired as-needed to ensure safety. Periodically clean with an appropriate cleaner and touch up paint as needed in between regular paint cycles. When evaluating replacements, be sure to comply with any applicable building codes. Gates and locks should be inspected to make sure they close and lock properly. Faulty perimeter around a pool area can expose an Association to significant liability risk. When possible, replacement should be coordinated with other projects, such as pool deck projects, other fencing/railing work, etc.

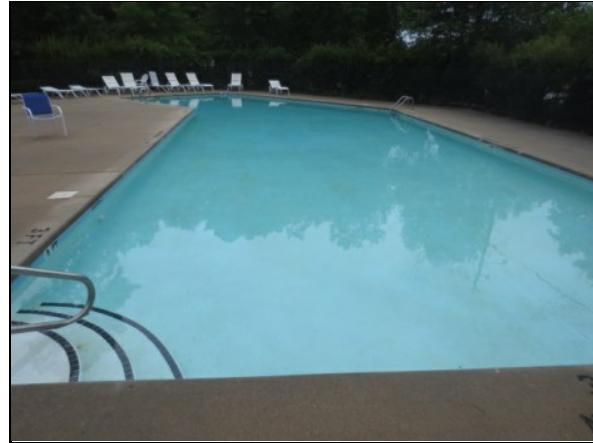
Evaluation: Pool surfaces were noticed to have blistering, minor cracking and staining in certain areas. Approximately 1,590 GSF footprint area with 175 LF waterline/perimeter length. Depth ranges from 3' to 5'. Pool resurfacing will restore the aesthetic quality of the pool while protecting the actual concrete shell of the pool from deterioration. While drained for resurfacing, any other repairs to lighting, handrails, stairs, ladders, etc. should be conducted as needed. This type of project is best suited for slow/offseason to minimize downtime during periods when pool is used heavily. Should be expected at the approximate interval shown below; in some cases, schedule may need to be accelerated due to improper chemical balances or aesthetic preferences of the Association.

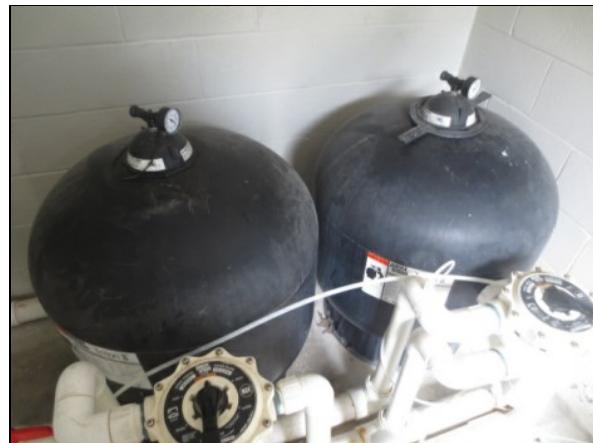
Evaluation: No issues were reported or noticed. Appeared to have minor surface wear. Pool vendor should inspect regularly for optimal performance and address any repairs or preventive maintenance as needed. Life can vary depending on location, as well as level of use and preventive maintenance. Plan to replace at the approximate interval shown below.

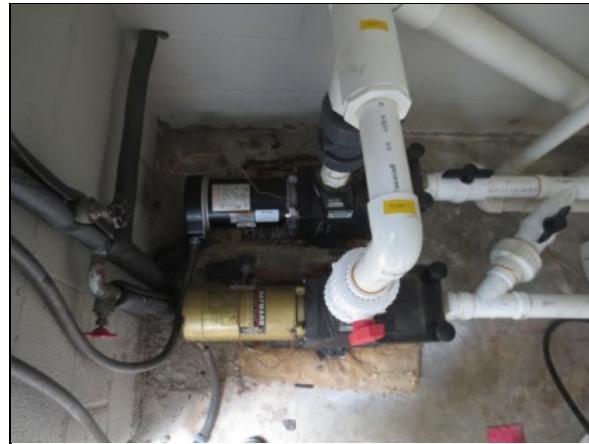
Evaluation: No issues reported. Pumps should be inspected regularly for leaks and other mechanical problems. Cost shown is based on replacement with the same type and size unless otherwise noted, and includes small allowance for new piping/valves/other repairs as needed.

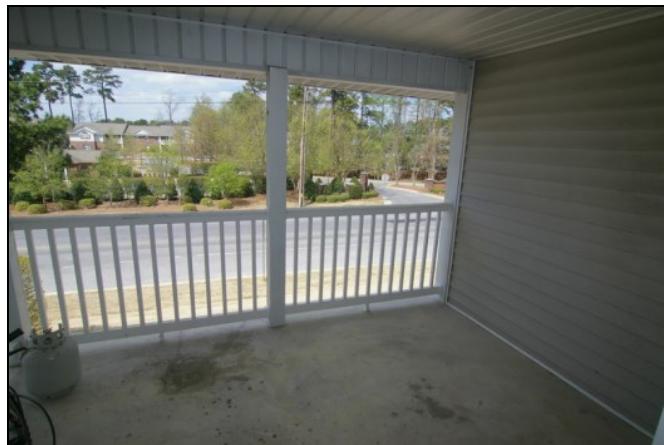
Evaluation: The balconies Even with regular preventive maintenance (cleaning/repairing/sealing), most decking systems will eventually wear down to the point of failure. However, these surfaces are all concrete and should have a long useful life. Typical warning signs that the surface may be failing include large cracks visible on surface or from beneath the deck, staining patterns, spalling/chipping concrete, etc. These decks are not expected to be replaced all at once time but rather as needed if advanced deterioration occurs. No reserve funding required at this time. Should be re-evaluated during later reserve studies.

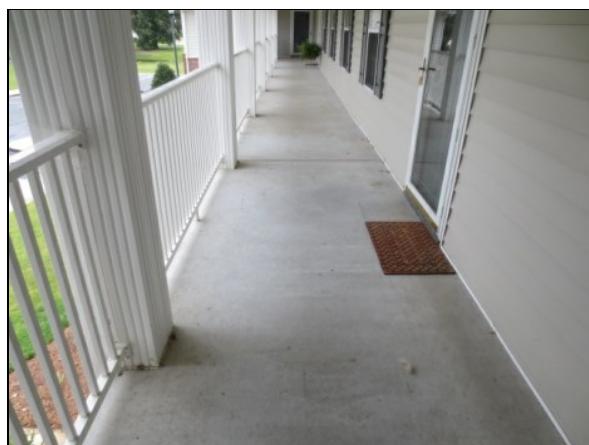
Evaluation: Surface wear noticed. Some minor cracking noticed. Even with regular preventive maintenance (cleaning/repairing/sealing), most decking systems will eventually wear down to the point of failure. However, this type of concrete walkway normally has a long unpredictable useful life. Best to have these walkway decks inspected to ensure there is no subsurface rusting or cracking. Typical warning signs that the surface may be failing include large cracks visible on surface or from beneath the deck, staining patterns, spalling/chipping concrete, etc. We recommend consulting with a structural engineer or building envelope or waterproofing specialist to define a comprehensive scope of work if large project are needed. No reserve funding at this time but should be reevaluated during a future reserve study.

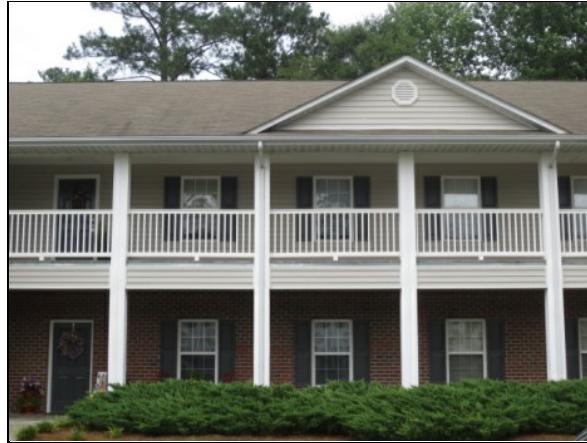
Evaluation: The doors and shutters were repainted and make up the majority of the painted surfaces on the buildings. Minor scuffing and surface wear was noticed. No major damage was noticed. Painted exterior surfaces (Doors and shutters) determined to be in fair condition typically exhibit some minor to moderate signs of wear and age such as chalking, peeling, blistering, etc. Problems tend to develop in more exposed areas first. Hairline cracks may be present at this stage. Overall appearance is satisfactory. There are two important reasons for painting and waterproofing a building: to protect the structure from damage caused by exposure to the elements, and to restore or maintain good aesthetic standards for curb appeal. As routine maintenance, we recommend that regular inspections, spot repairs and touch-up painting be included in the operating budget.

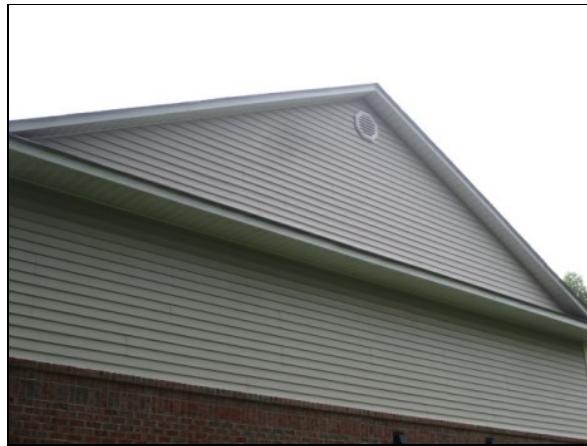
Evaluation: Vinyl surfaces were in fair condition overall. No major damage was noticed. Surface wear was noticeable throughout. No view of the underlying waterproofing was undertaken as part of this limited visual review. Vinyl siding will fade over the years and when replacing pieces it may be difficult to match the faded color. This component does not include the recent walkway ceiling replacement project. Those ceiling areas are protected from the elements and should have a long useful life. Repair the ceiling areas as needed. Possible funding could be required in future reserve studies. Best to reevaluate at a later date. The useful life expectancy shown below is for financial planning purposes. Evaluate the siding, and the critical underlying waterproofing (building paper or house wrap) as the remaining useful life approaches zero years. Adjust remaining useful life as dictated by the evaluation of performance of the underlying waterproofing. Cost estimates shown here assume that siding will be replaced with a similar vinyl material again; if other siding types are considered for replacement, the Reserve Study should be updated accordingly to incorporate new estimates.
