## **"Full" Reserve Study**

### **Turtle Creek Condominiums Homeowners Association Greenville, NC**

**Report #: 37759-0**

**Date Prepared: August 19, 2020**

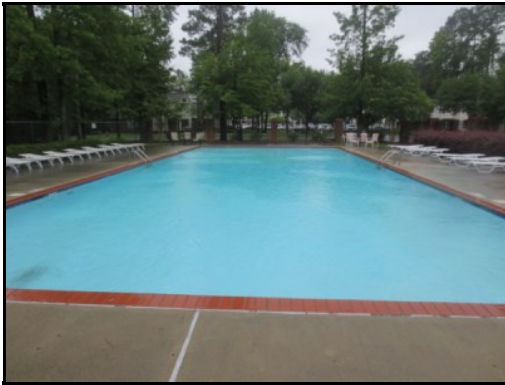
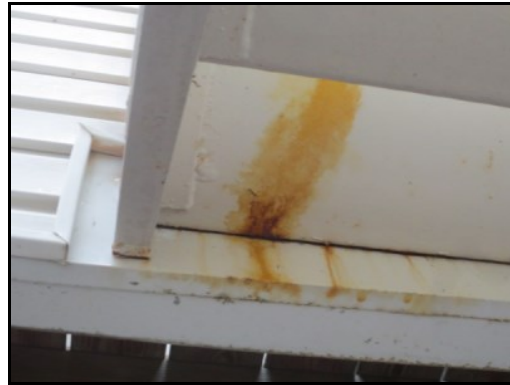
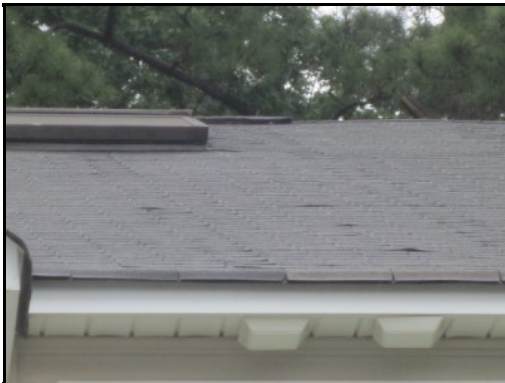
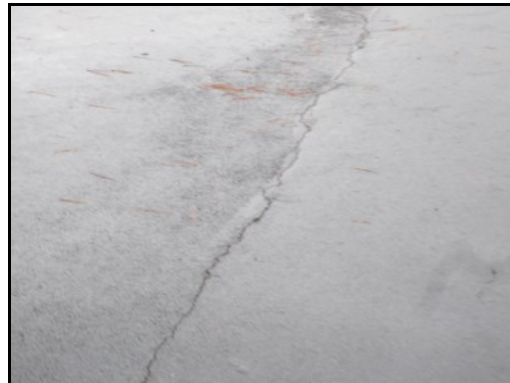
During our site visit on 6/29/2020, we met with the property manager who was able to give us access to all locked areas and mechanical rooms. I visually inspected all the buildings and were able to see most areas. We recommend completing roofing inspection in the near future to gain a better understanding of the RUL of all roofs. Another best practice is to have the drainage areas inspected and cleaned where needed. Roofs, asphalt, and metal staircases have photos below that show area of deterioration that were noticed.

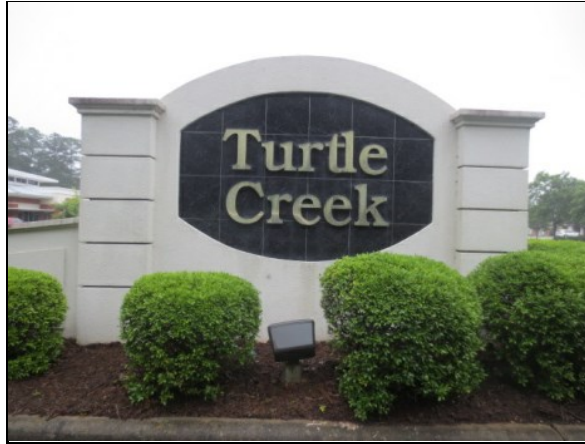
Comments: Entry signs was welcoming but had some surface wear noticed. Signs should be power washed and repaired as an operating expense. Monument signage determined to be in fair condition typically exhibits acceptable appearance and aesthetics in keeping with local area, but with more weathering and wear showing on surfaces. If present, landscaping and lighting are still in serviceable condition. At this stage, signage may be becoming more dated and diminishing in appeal. As routine maintenance, inspect regularly, clean/touch-up and repair as an Operating expense. Plan to refurbish or replace at the interval below. Timing and scope of refurbishing or replacement projects is subjective but should always be scheduled in order to maintain good curb appeal. In our experience, most Associations choose to refurbish or replace signage periodically in order to maintain good appearance and aesthetics in keeping with local area, often before signage is in poor physical condition. If present, concrete walls are expected to be painted and repaired as part of refurbishing, but not fully replaced unless otherwise noted. Costs can vary significantly depending on style/type desired, and may include additional costs for design work, landscaping, lighting, water features, etc. Reserve Study updates should incorporate any estimates or information collected regarding potential projects.

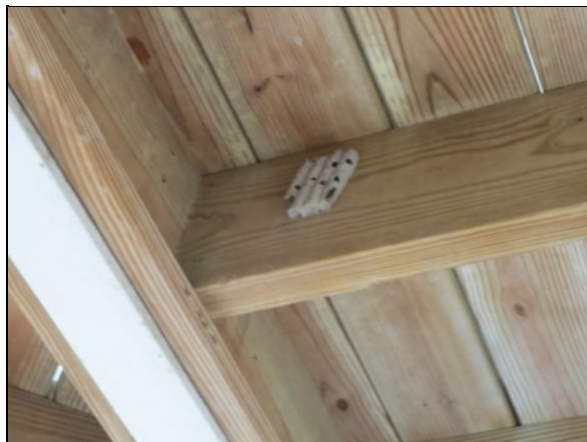
Comments: No significant repairs reported. Funding for a repair allowance. Overall walking decks are in fair condition.
