Autumn Lakes Homeowners Association, Inc  
Master Association  
*Grimesland, NC*

Report #: 42465-0  
Beginning: January 1, 2022  
Expires: December 31, 2022

**RESERVE STUDY**  
**"Full"**

February 1, 2022

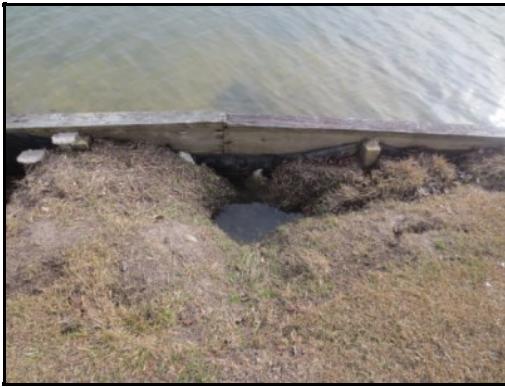
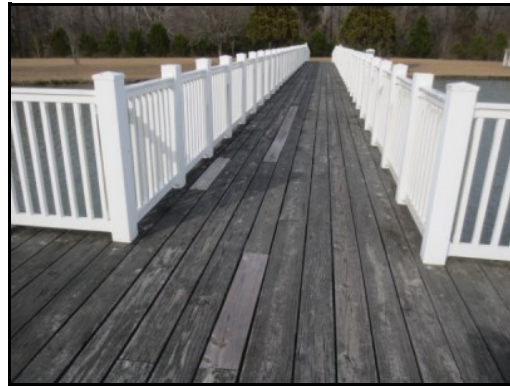
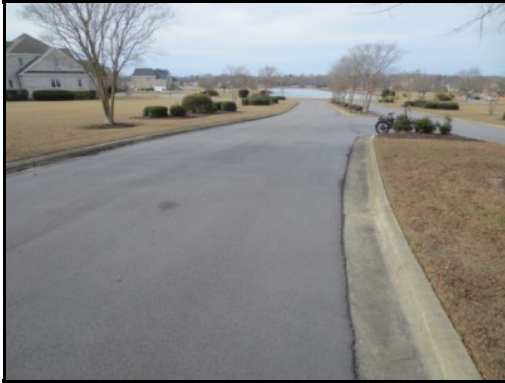
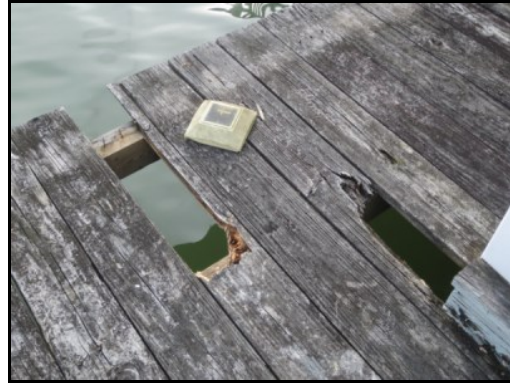
During our site visit on 1/13/2022, we met with the property manager, who was able to explain in detail the recent projects that were recently finished and what projects are expected to occur in the next five years. The bridges and docks were all noted to be aging and expected to require large projects in the upcoming years. It is highly recommended that engineers inspect the bridges and docks to ensure they are safe and possibly identify any hidden deterioration. Missing sections of the dock could be a safety hazard to the unit owners.

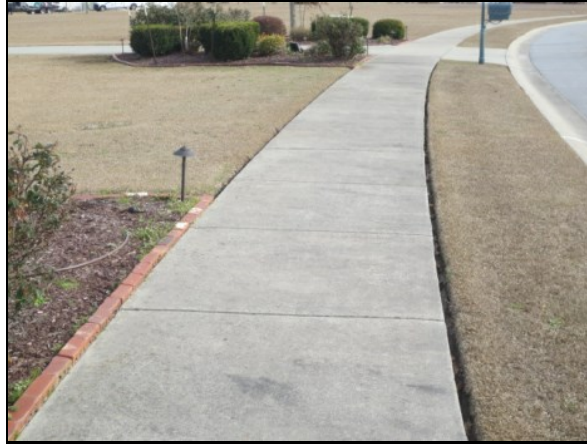
**Comp #: 2107 Concrete Paths - Partial Repair**

Comments: There were no consistent issues with cracking or erosion throughout the property. Concrete sidewalks determined to be in fair condition typically exhibit minor changes in slope and a moderate percentage of cracking and surface wear. Trip hazards may be increasing in frequency and severity and should be closely monitored to prevent further risks. Repair any trip and fall hazards immediately to ensure safety. As routine maintenance, inspect regularly, pressure wash for appearance and repair promptly as needed to prevent water penetrating into the base and causing further damage. In our experience, larger repair/replacement expenses emerge as the community ages, especially as trees adjacent to sidewalks continue to grow. Although difficult to predict timing, cost and scope, we suggest a rotating funding allowance to supplement the operating/maintenance budget for periodic larger repairs. Adjust as conditions, actual expense patterns dictate within future Reserve Study updates.

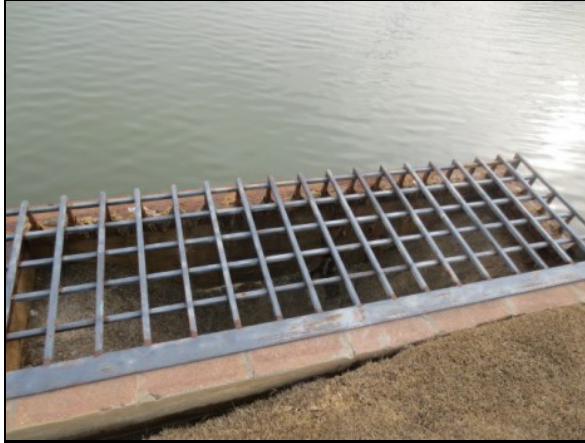
**Comp #: 2113 Site Drainage System - Clean/Repair**

Comments: No access to inspect in-ground drainage infrastructure. Annual preventive maintenance work is typically performed as part of an Association's general maintenance/operating fund. Under normal circumstances, site drainage components are constructed of very durable materials which should have an very long useful life (often assumed to be 50 years or more). Repairs may occasionally be required, but timing and scope of work is too unpredictable for Reserve funding in accordance with National Reserve Study Standards. If there are specific, known concerns with drainage system, we recommend further investigation using cameras or other means to document and identify conditions. Some Associations consult with civil and/or geotechnical engineers in order to develop scopes of work for repair/replacement. If more comprehensive analysis becomes available, findings should be incorporated into Reserve Study updates as appropriate.

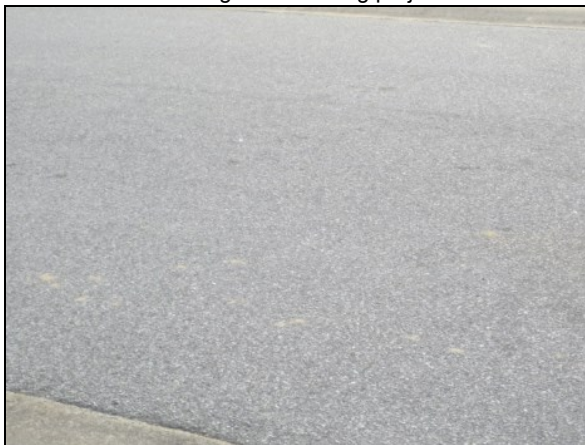
**Comp #: 2123 Asphalt (All) - Repair**

Comments: Repairs will be required in between the larger resurfacing projects. This is a small allowance for these projects.

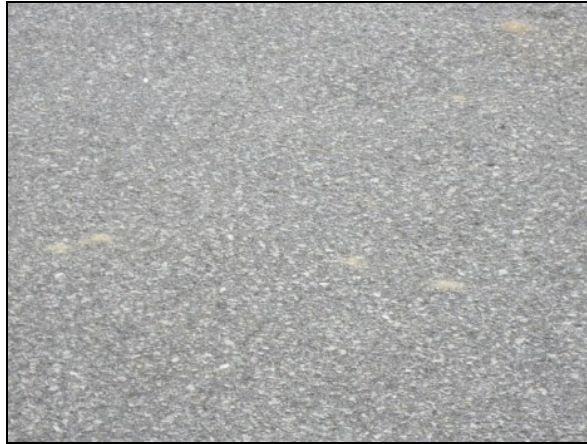
Comments: This section of asphalt is overall aging well. A resurfacing will likely have to be completed in 5-10 years. Asphalt pavement determined to be in fair condition typically exhibits a mostly uniform surface but with minor to moderate raveling and surface wear. If present, crack patterns are normal for the age of the asphalt and not extreme, and there are no signs of advanced deterioration, such as large block cracking patterns, "alligatoring" or potholes. Overall appears to be aging normally and still up to an appropriate aesthetic standard. As routine maintenance, keep roadway clean, free of debris and well drained; fill/seal cracks to prevent water from penetrating into the sub-base and accelerating damage. Even with ordinary care and maintenance, plan for eventual large scale resurface (milling and overlay of all asphalt surfaces is recommended here, unless otherwise noted) at roughly the time frame below. Take note of any areas of ponding water or other drainage concerns, and incorporate repairs into scope of work for resurfacing. Our inspection is visual only and does not incorporate any core sampling or other testing, which may be advisable when asphalt is nearing end of useful life. Some communities choose to work with independent paving consultants or engineering firms in order to identify any hidden concerns and develop scope of work prior to bidding. If more comprehensive analysis becomes available, incorporate findings into future Reserve Study updates as appropriate.

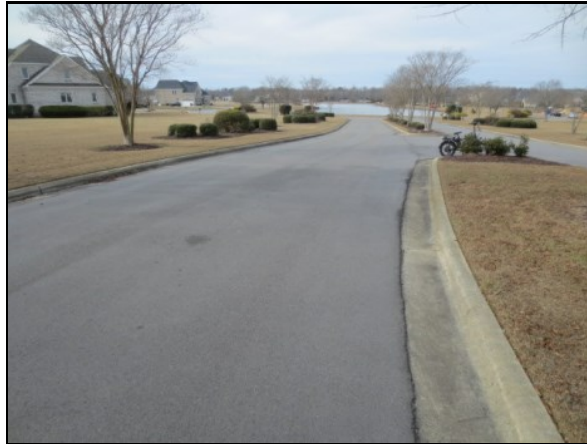
Comments: Asphalt pavement determined to be in good condition typically exhibits a consistent appearance with uniform coloring and relatively smooth texture with only light to moderate signs of wear or age. If present, cracking and raveling or other signs of wear are sporadic in nature, and asphalt is still up to aesthetic standards for the development. No unusual signs of wear considering the age of the asphalt surface. As routine maintenance, keep roadway clean, free of debris and well drained; fill/seal cracks to prevent water from penetrating into the sub-base and accelerating damage. Even with ordinary care and maintenance, plan for eventual large scale resurface (milling and overlay of all asphalt surfaces is recommended here, unless otherwise noted) at roughly the time frame below. Take note of any areas of ponding water or other drainage concerns, and incorporate repairs into scope of work for resurfacing. Our inspection is visual only and does not incorporate any core sampling or other testing, which may be advisable when asphalt is nearing end of useful life. Some communities choose to work with independent paving consultants or engineering firms in order to identify any hidden concerns and develop scope of work prior to bidding. If more comprehensive analysis becomes available, incorporate findings into future Reserve Study updates as appropriate.
