Locksley Woods COA
Greenville, NC

RESERVE STUDY
Update "With-Site-Visit"

September 26, 2022

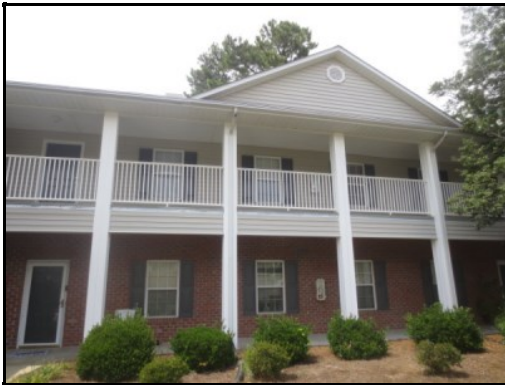
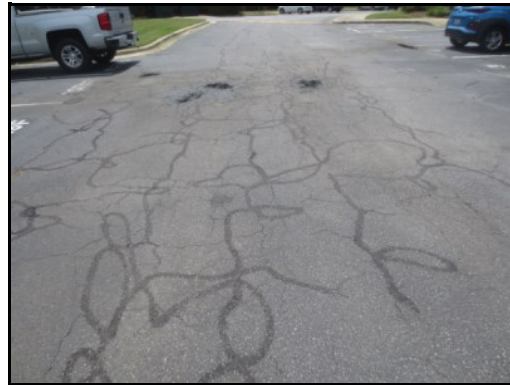
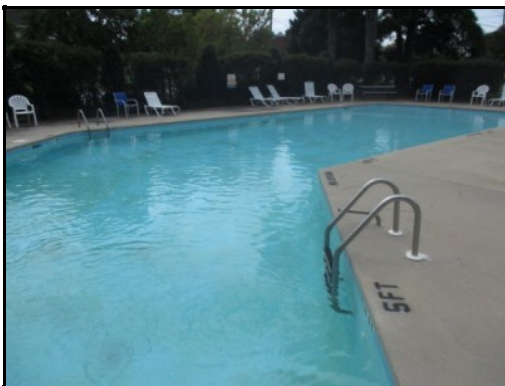
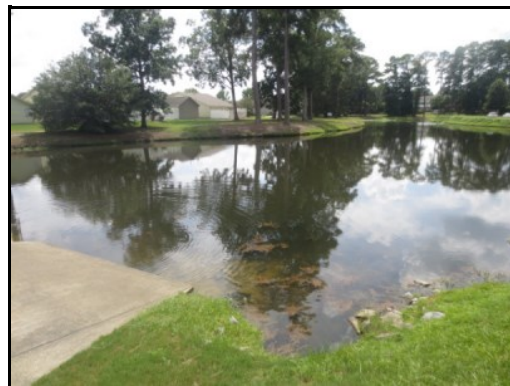
Site Inspection Notes

During our site visit on 8/23/2022, we met with the property management team to discuss some of the recent projects that took place and what adjustments need to be made since the last site visit. It was reported that there had been numerous issues with water table issues. It was also reported that many of the drainage components like the ponds and drainage streams will likely require large projects to clean out and remove some of the overgrowths. This will ideally allow the stormwater to travel unimpeded after heavy rains.

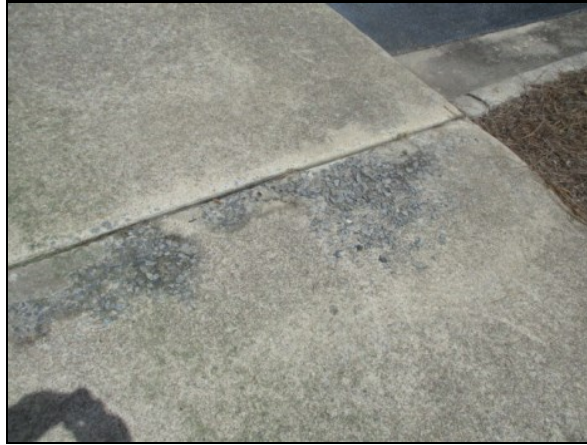
Comp #: 2107 Concrete Sidewalks - Repair

Useful Life:
5 years

Remaining Life:
2 years

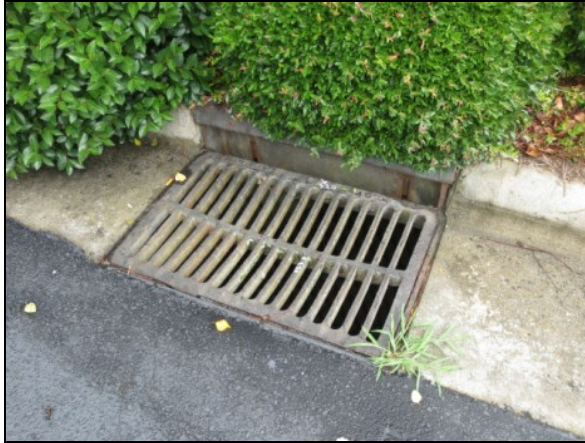
Comp #: 2113 Site Drainage System - Clean/Repair

Useful Life:
30 years

Remaining Life:
1 years

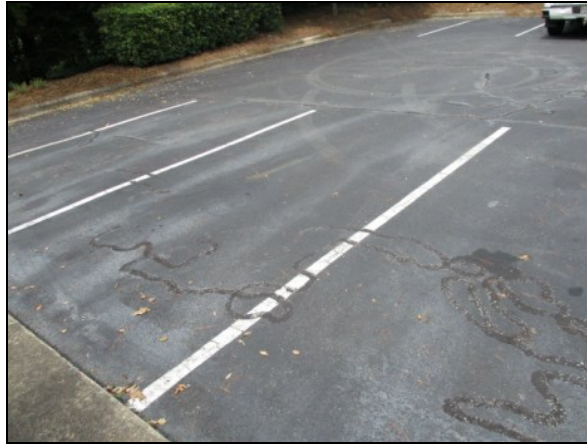
Comp #: 2123 Asphalt - Seal/Repair

Useful Life:
5 years

Remaining Life:
7 years

Lower estimate to seal/repair
