FULL RESERVE STUDY

***WILLOUGHBY PARK
GREENVILLE, NC***

Prepared for:
***WILLOUGHBY PARK CONDOMINIUM ASSOCIATION
GREENVILLE, NC
&
HOA MANAGEMENT COMPANY, LLC***

OCTOBER 10, 2013

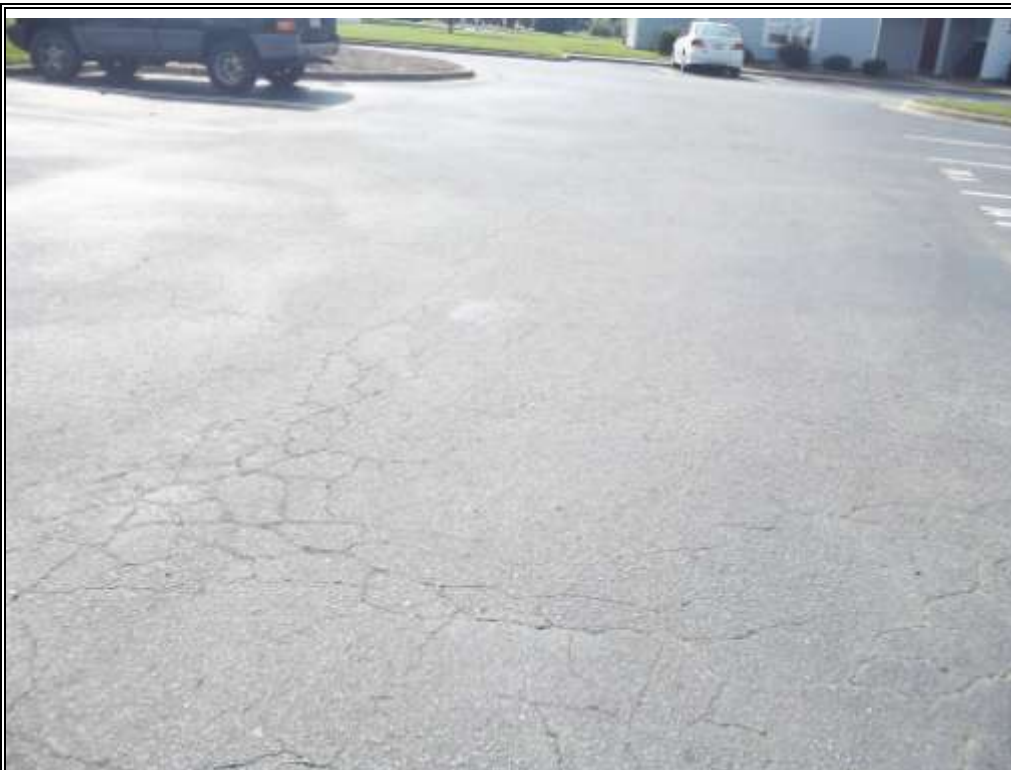
Photo Number
2

Description:
Cracking and
alligatoring
observed in
sections of paving.

We observed several areas of cracking and depressions beginning to form in the asphalt. The cracking and depressions were generally more significant in the area of the community to the south of the pool and entrance drive. We also observed many areas with significant alligatoring (cracking), depressions and pot-holes in the asphalt paving that will require repair in the immediate term. The total amount of paving in these areas was measured to be approximately 500 square yards. We have allocated funds for full depth repairs of these sections of paving beginning in 2014.

Note that it is likely that additional sections of cracking and depressions will develop and we have allocated funds for full depth repairs on a 5 year cycle. Full depth repairs would include saw cut and removal of sections of asphalt around the deteriorated areas. The sub-grade should be repaired and tamped as needed and a new 3" to 4" thick layer of asphalt should be installed.

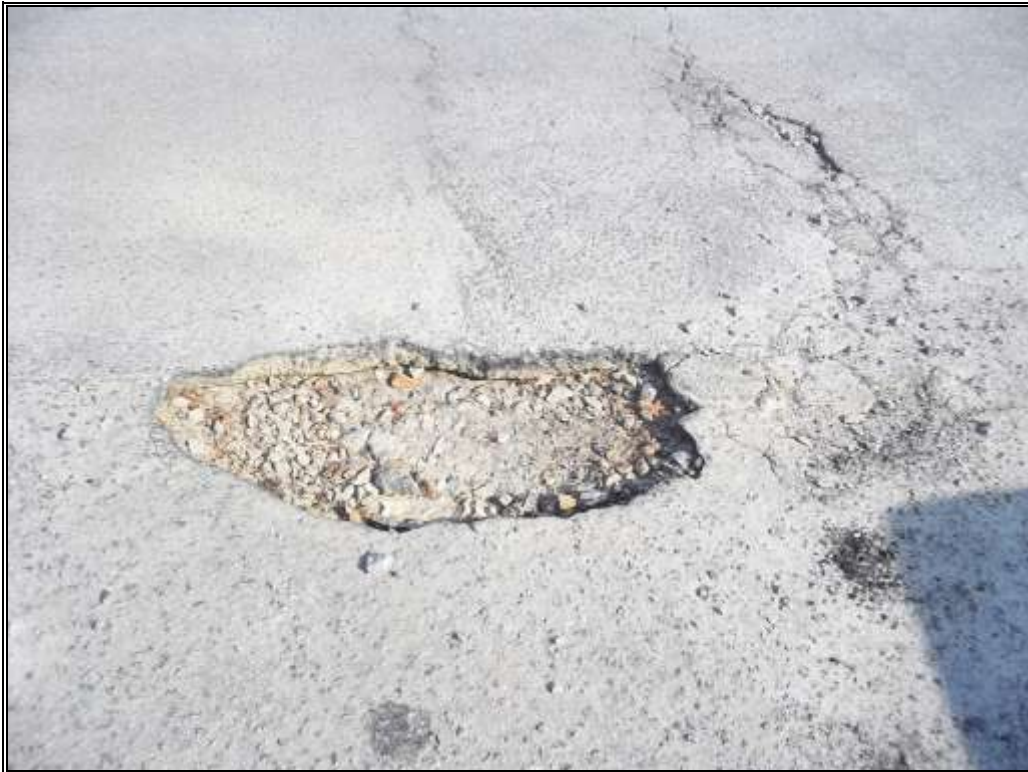
Photo Number

Pot hole observed in paving, requiring full depth repair in near term.

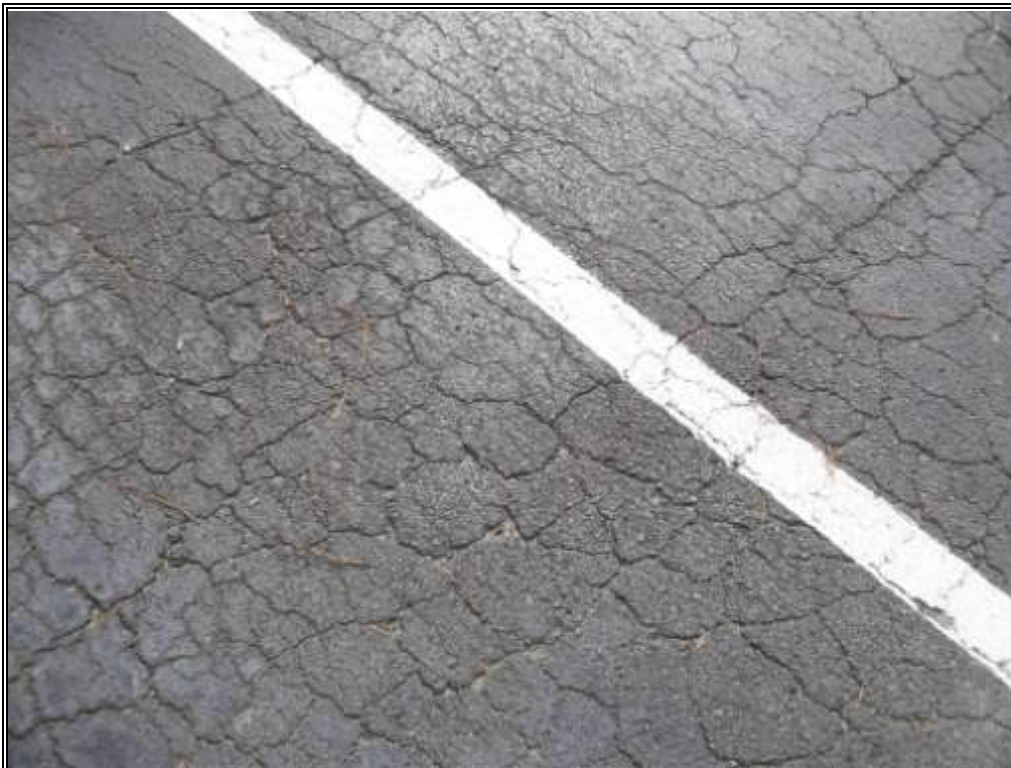
Significant alligatoring and cracking observed in sections of the paving.

If full depth repairs, sealant and crack repairs are accomplished in the interim, we anticipate the asphalt paving in the community to have an estimated remaining useful life of approximately five to ten years. We have allocated funds to resurface the asphalt paving on the south side of the community in 2019 and the north side of the community in 2024. This allocation would include installing a new 1.5" to 2" thick wearing layer of asphalt over the entire parking area. Note that during resurfacing, areas of significant cracking/alligatoring or depressions will require full depth

repair as part of the resurfacing project. We have included an allocation of funds to complete the full depth repairs as needed.

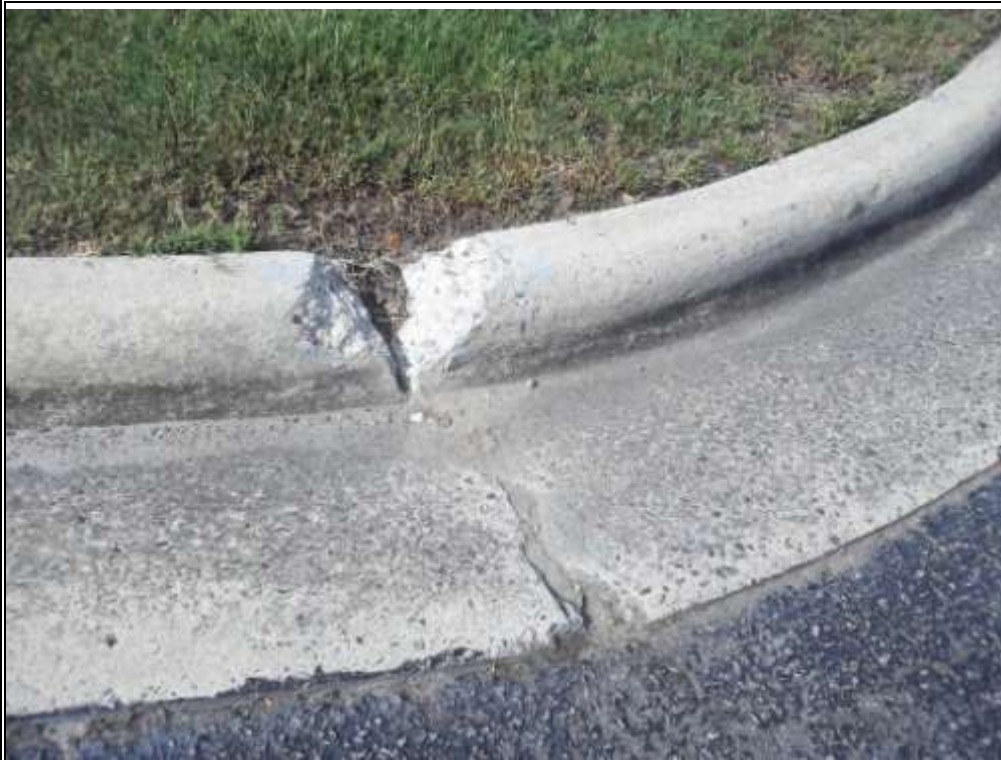
Photo Number

Cracking and deterioration noted in sections of concrete curbing.

The concrete curbing along the paved areas generally appeared to be in good to fair condition. We noted limited sections of significant cracking and upheaval in the concrete curbing. It is likely that due to differential settlement, cracking will continue to develop and sections of the concrete curb will require repair on an approximately 4 year cycle. We have allocated funds to repair approximately 2.5% of the total amount of concrete curbing every 5 years, beginning in 2015.

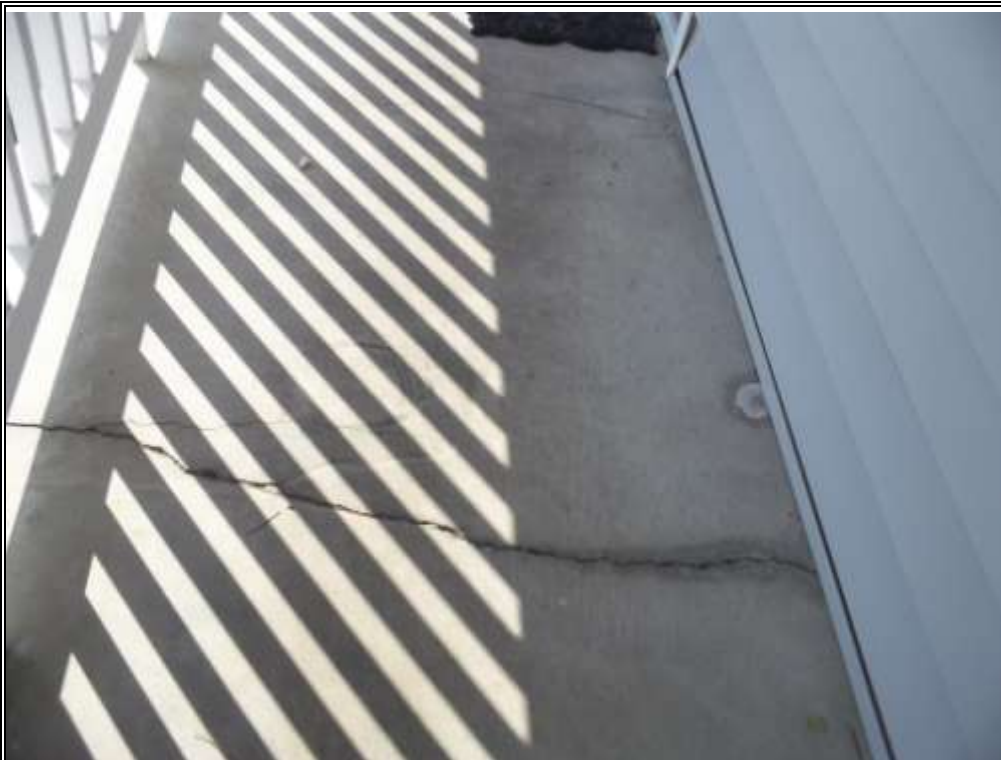
Cracks developing in elevated concrete balconies on the front of the buildings.

Concrete sidewalks are located in front of the buildings and along the parking areas. Concrete patios are located at the rear of each building. The deck around the swimming pool and the dumpster pads are also comprised of concrete. Elevated concrete balconies serve the front entry of the 2nd floor units. The concrete sidewalks and flatwork generally appeared to be in good to fair condition. We noted limited sections of significant upheaval in the concrete sidewalks and flatwork and minor cracking in the elevated concrete balconies on the front of the buildings. We have allocated funds for periodic replacement of concrete surfaces as required and have assumed that 2.5% of the surfaces will require replacement every 5 years beginning in 2015.

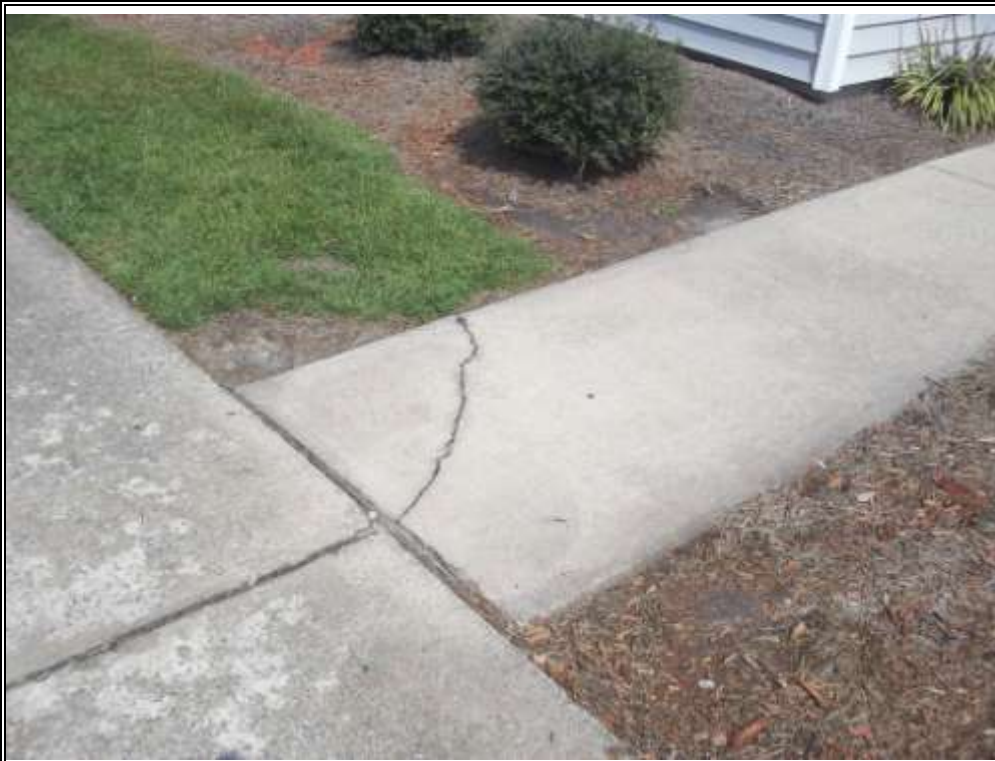
Photo Number
7

Description:
Cracks developing
in sidewalks.

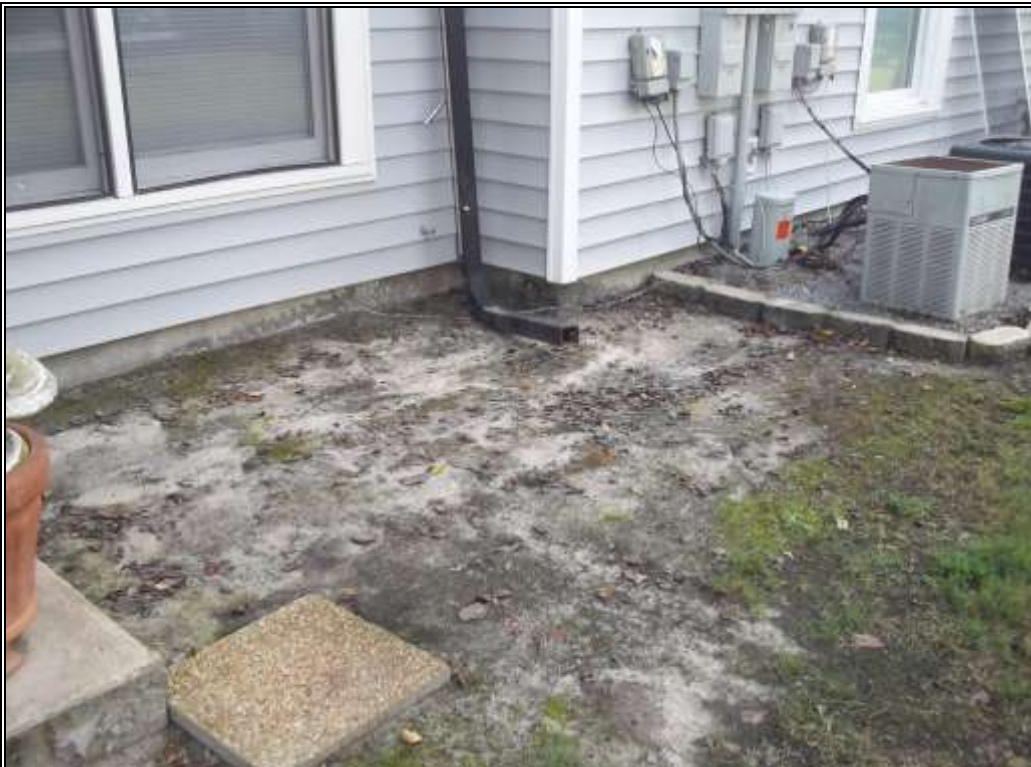
Photo Number
8

Description:
Bare
soils/inadequate
ground cover
noted in some
areas around
buildings.

We have allocated funds to repair/improve the drainage systems on a 4 year cycle beginning in 2018. Improvements would likely include retrenching swales, cleaning/repairing underground stormwater piping, installing new french drains and other drainage/erosion control measures. As a general maintenance recommendation to reduce soil erosion we advise maintaining adequate soil stabilizing ground cover vegetation throughout the common areas.

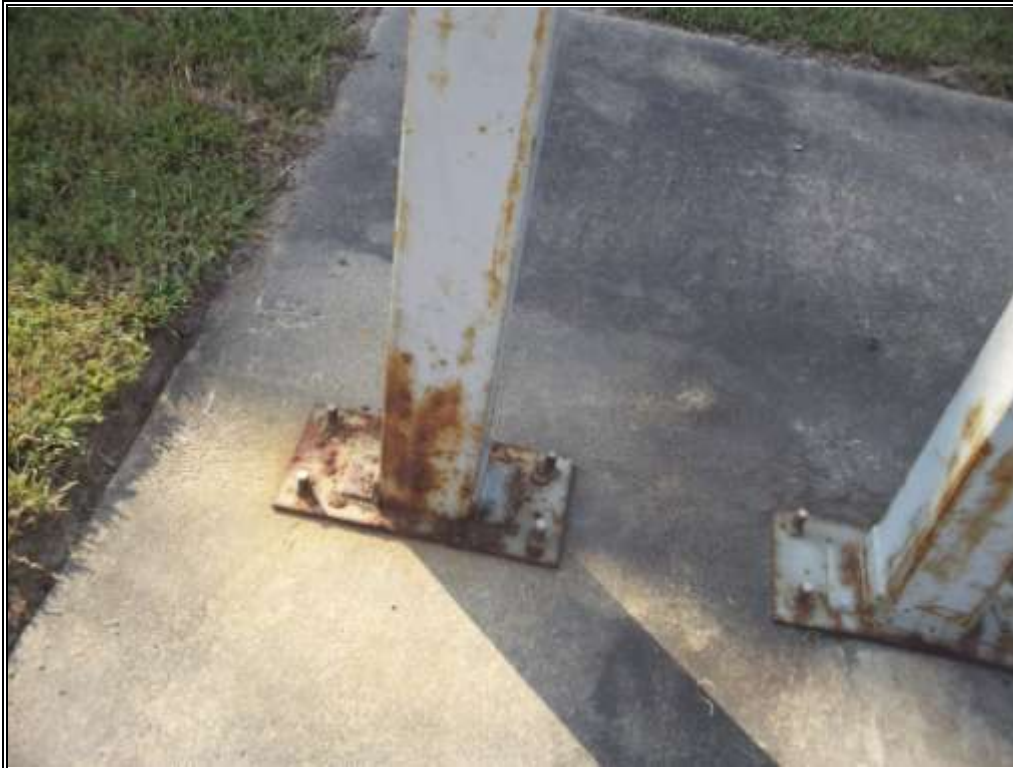
Photo Number
9

The association is responsible for maintaining the mailbox centers throughout the community. The mailbox centers appeared to be fair to poor condition. Significant surface rust and corrosion was noted on most of the mailbox units and bases. We have allocated funds for their

Description:
Rust and deterioration noted on mailbox kiosk posts.

replacement in 2014.

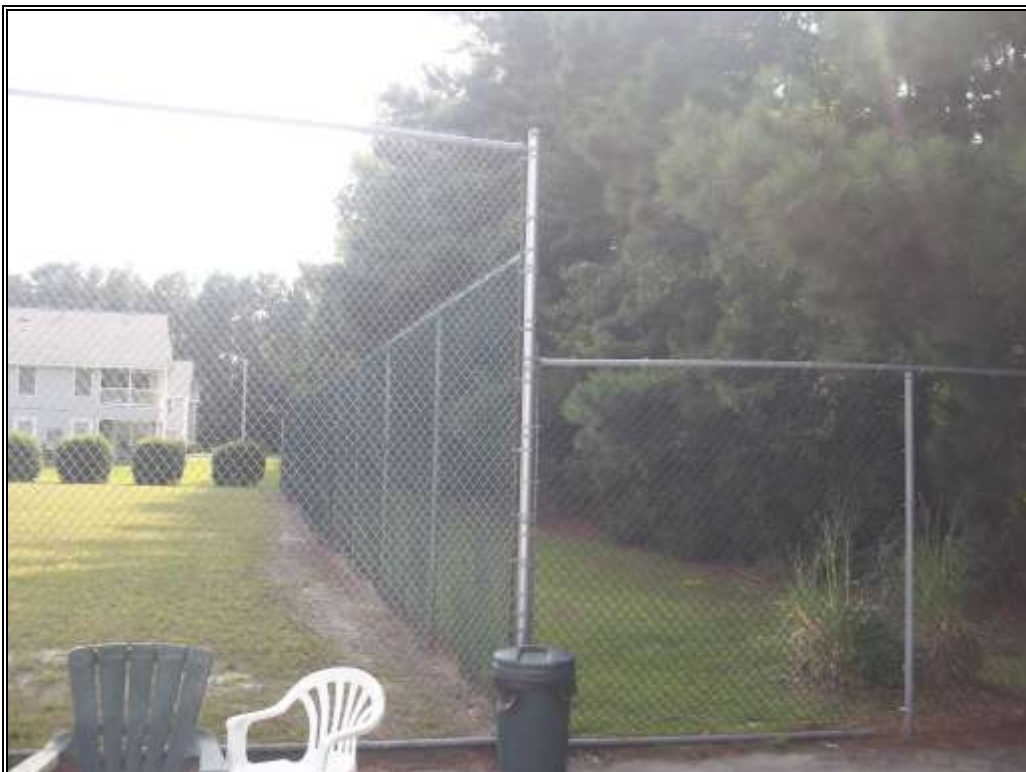
Photo Number
10

A section of chain link fencing has been installed on adjacent to the swimming pool area. The fencing appeared to be in good to fair condition. We estimate that the chain link fencing will require significant repairs or replacement in the next 5 to 10 years. We have allocated funds to replace the fencing in 2022. Vinyl fencing is installed around the dumpster pads in the community, we do not anticipate the vinyl fencing will require significant repair over the next 20 years.

Description:
Chain link fencing in pool area.

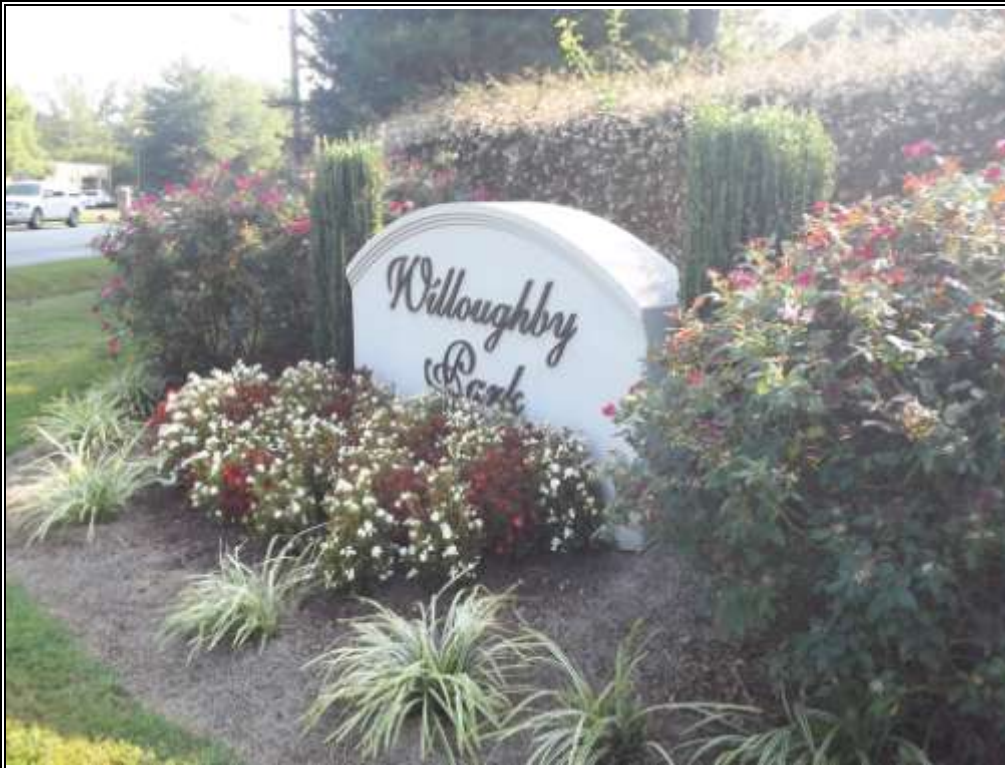
Photo Number
11

A small entrance sign is located at the entrance of the community. The sign includes a stucco/EIFS finish with raised painted lettering. The sign generally appeared to be in good condition. We have allocated funds to repair the entrance sign on a 10 year cycle beginning in 2019.

Description:
Entrance sign.

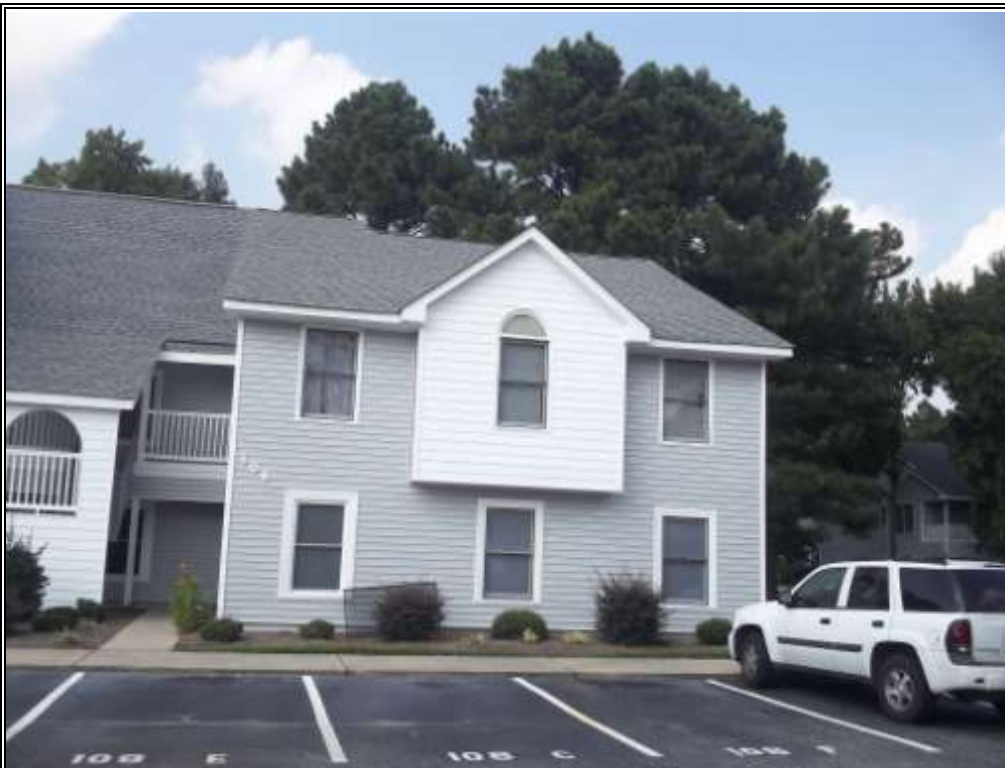
Photo Number
12

The vinyl siding and trim components were reportedly installed in approximately 2008. The vinyl siding and trim components generally appeared to be in good condition and have expected useful lives beyond the term of this study. However, minor repairs will likely be required, which we have assumed would be funded from an annual operating budget.

Description:
Typical building
front view, roofs,
siding, and trim.

Painting of exterior doors and painted trim on the condominium buildings will also be required over the term. We have allocated funds for miscellaneous repairs to the siding and trim and to paint the exterior doors and trim on a seven year cycle beginning in 2019. The exteriors doors and painted trim of the pool buildings and storage room buildings should be painted in conjunction with the condominium buildings.

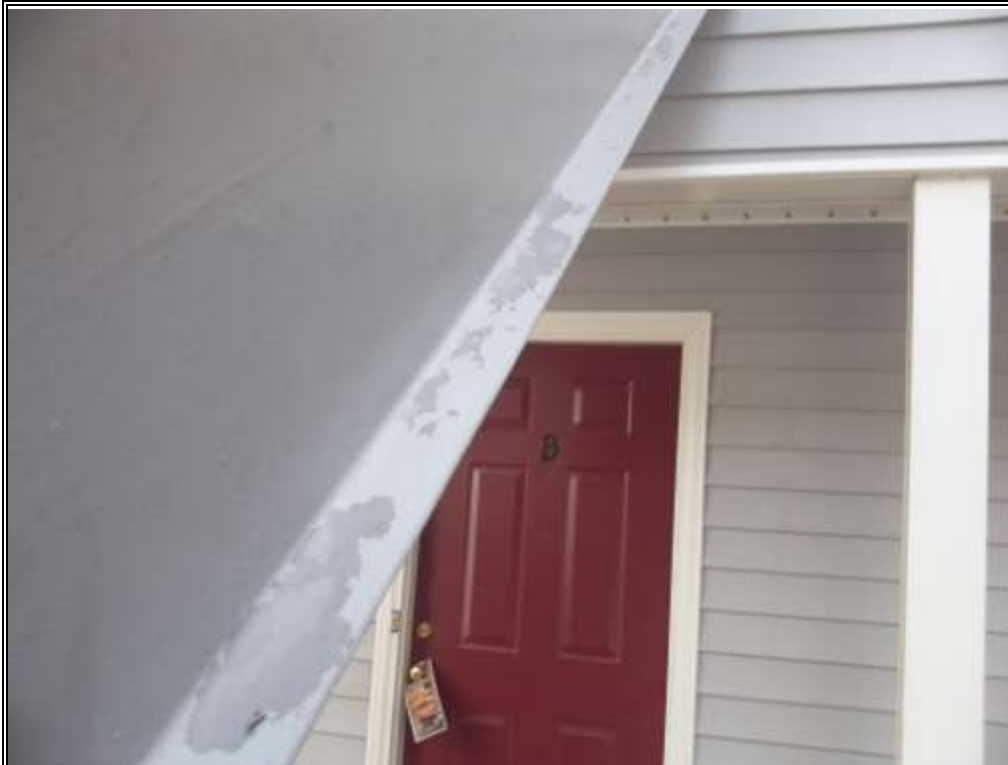
Photo Number
14

The 2nd floor units of each building are served by a painted metal framed exterior stairway with concrete treads. The metal stairways varied in condition. Approximately ½ of the stairways appeared to have been recently painted and were in good condition. The remaining stairways varied in condition, several were observed to have flaking paint and minor corrosion developing on the metal surfaces. We have allocated funds to paint and repair approximately half of the metal stairways every 5 years beginning in 2014.

Description:
Flaking paint on
stairway structure.

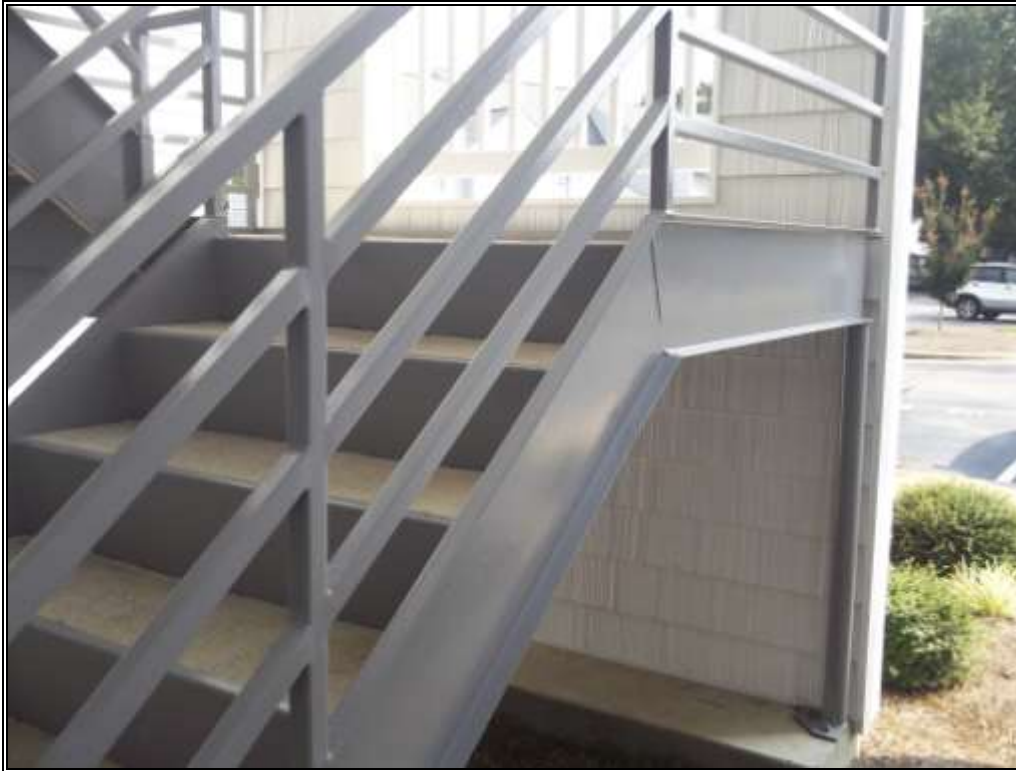
Photo Number
15

Description:
Stairway in good
condition and
appears to be
recently painted.

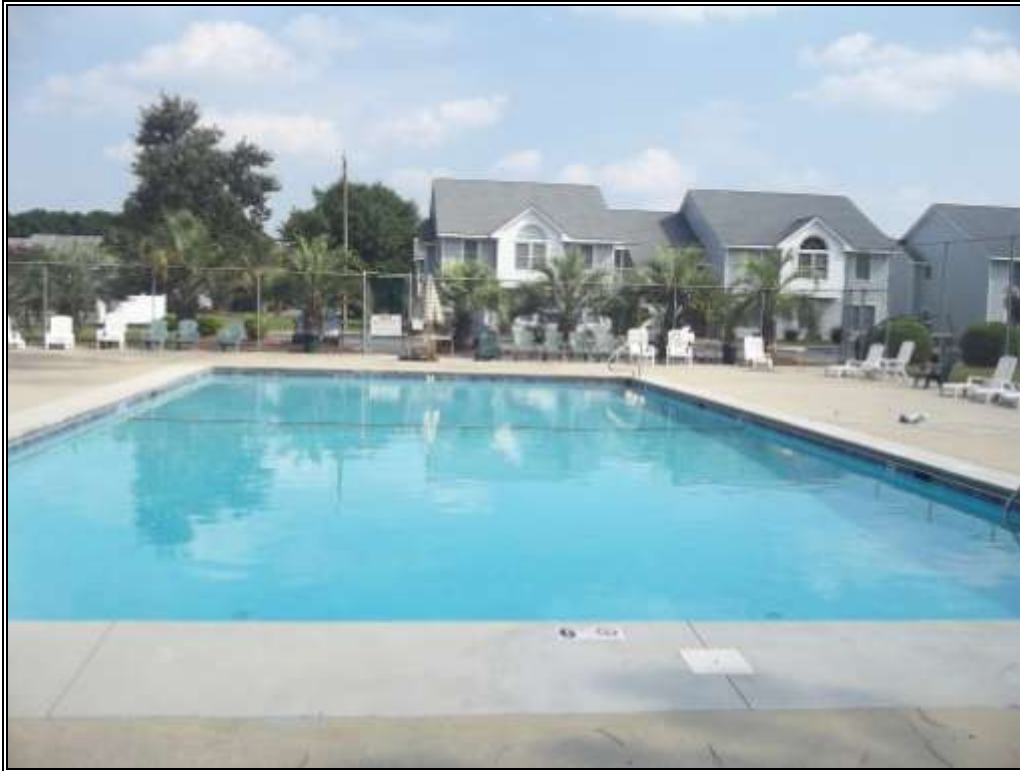
Photo Number
17

The pool surface generally appeared to be in good condition. The surface appears to have been recently re-coated. The coping around the edge of the pool also appears to have been recently repaired. The pool surface will likely require repairs and re-coating on an approximately 12 year cycle. The repairs would likely include crack repairs, removal of existing coating and recoating/plastering the pool surface. We have allocated funds for the pool surface repairs and recoating beginning in 2024.

Description:
Swimming pool.

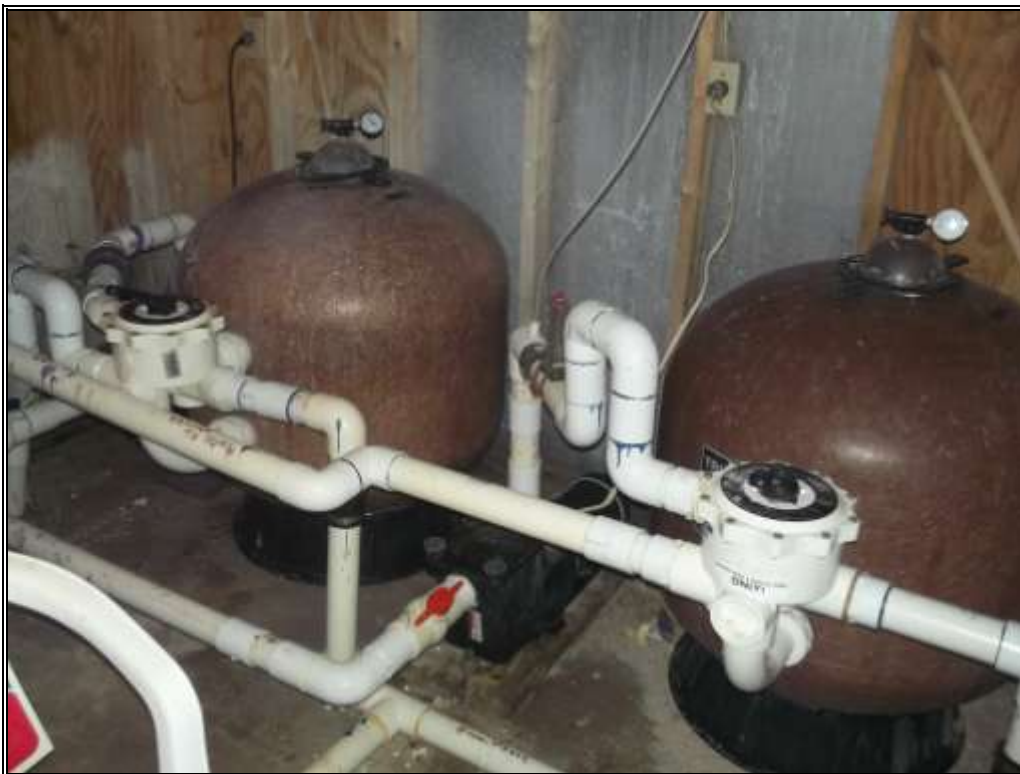
Photo Number
18

The swimming pool is served by two 2-horsepower pumps and two Triton sand filters. We anticipate that the pool pumps, motors, filters and equipment will require significant repair on an approximately 3 year cycle and we have allocated funds for repairs beginning in 2017. We observed surface rust and corrosion developing on the entrance doors to the pump room; we have allocated funds to replace the door on a 12 year cycle beginning in 2014. We also observed significant surface rusting on the electrical breaker panel in the pump room and we have allocated funds for its replacement in 2014.

Description:
Pool pump and
filtration
equipment.

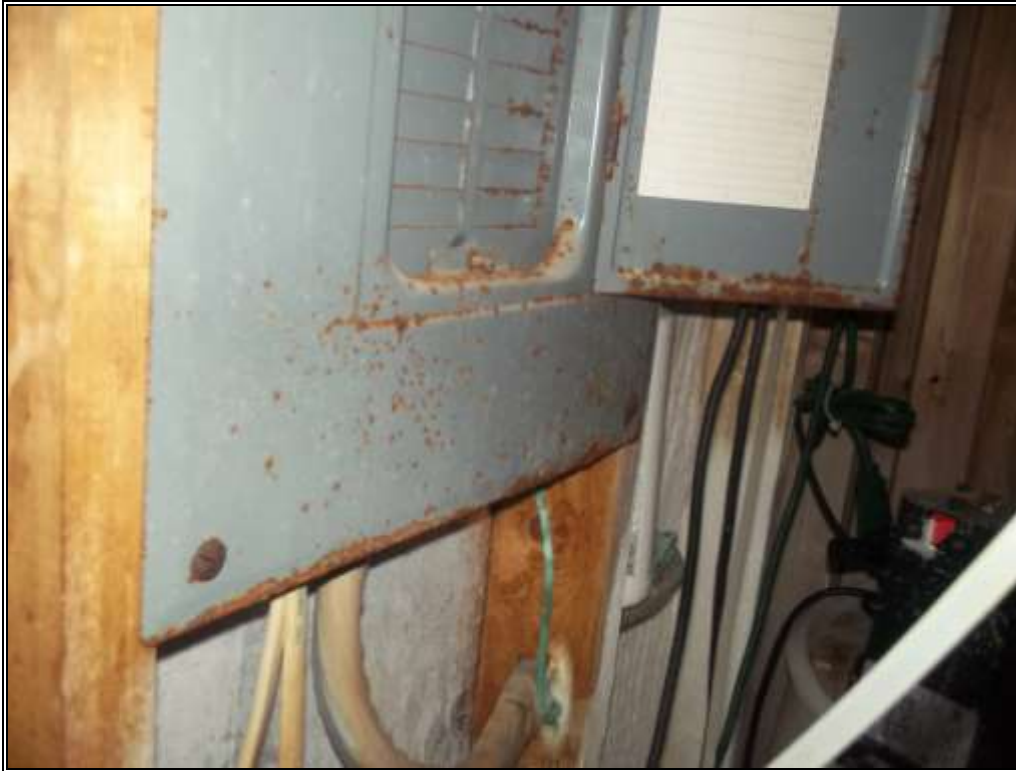
Photo Number
19

Surface rust noted
on electrical panel
in pump room.

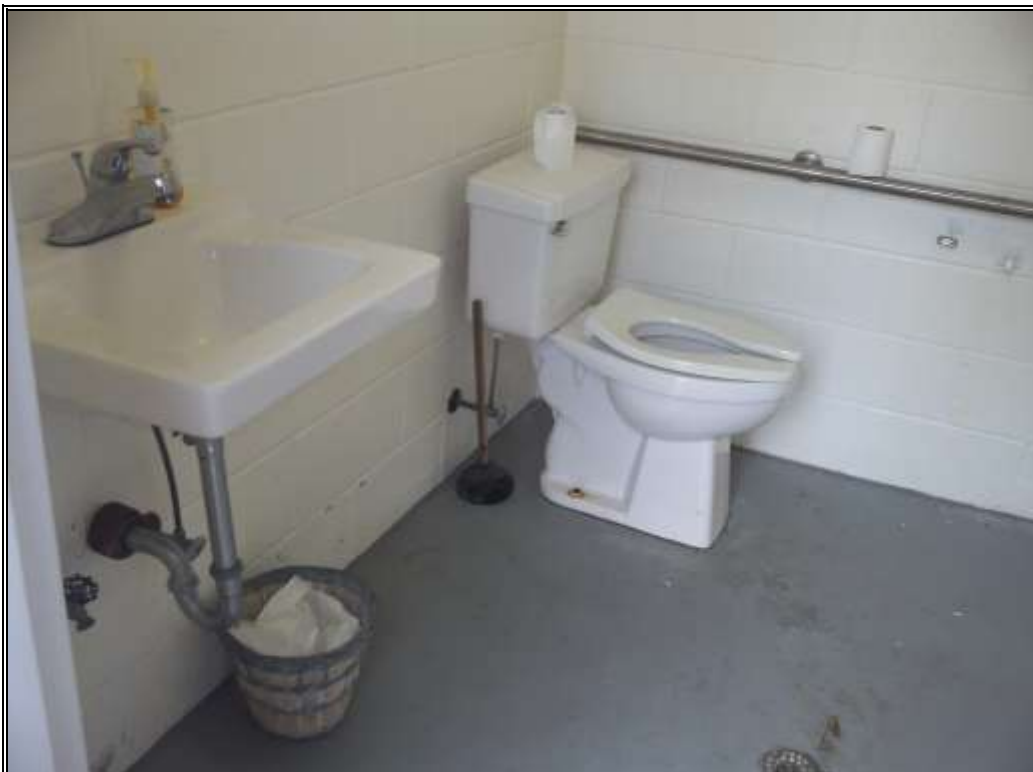
The swimming pool includes a men's and women's restroom. The restrooms each include a sink and toilet and painted block walls. A small shower fixture is also provided. The restroom fixtures appeared to be in fair condition and of original construction. We noted surface rust developing on some of the fixtures. We have allocated funds to replace the fixtures on a 15 year cycle beginning in 2014.

Restroom fixtures.
