Locksley Woods COA
Greenville, NC

RESERVE STUDY
Update "With-Site-Visit"

September 26, 2022

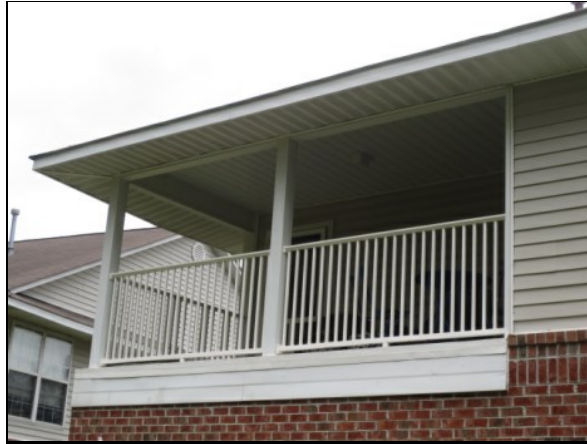
Comp #: 2326 Balcony Railings - Replace

Comments: Surfaces were not closely inspected. No major damage noticed. Post attachments and hardware should be inspected periodically for corrosion/rust and any waterproofing issues. As routine maintenance, inspect regularly to ensure safety and stability; repair promptly as needed using general operating/maintenance funds. We suggest Reserve funding for regular intervals of total replacement as indicated below. Costs shown are based on replacement with a similar style of railing.

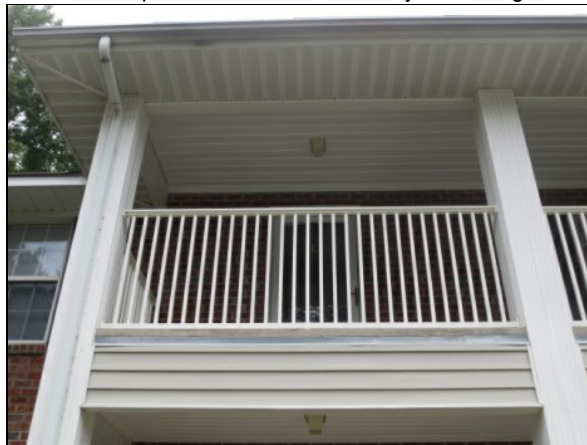
Comp #: 2328 Walkway Deck Railings - Replace

Comments: Surface wear noticed but no major damage. Post attachments and hardware should be inspected periodically for damage and any waterproofing issues. As routine maintenance, inspect regularly to ensure safety and stability; repair promptly as needed using general operating/maintenance funds. We suggest Reserve funding for regular intervals of total replacement as indicated below. Costs shown are based on replacement with a similar style of railing.

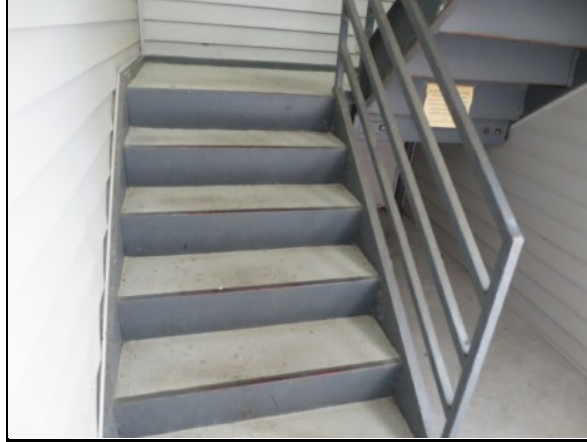
Comments: Many of these staircases need to be repainted and cleaned as rusting was noticed. These railings were a combined 640 LF total. As routine maintenance, inspect regularly and perform any needed local repairs promptly as general maintenance expense. Staircases should be inspected regularly to ensure safety and stability; repair promptly as needed using general Operating funds. Make sure that all steps and landings drain properly to avoid standing water which can lead to slip and fall hazards.

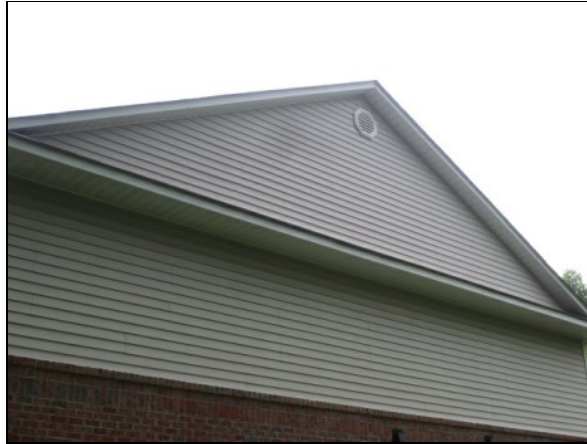
Comp #: 2356 Vinyl Siding (Phase 1) - Replace

Comments: Vinyl surfaces were in fair condition overall. No major damage was noticed. Surface wear was noticeable throughout. No view of the underlying waterproofing was undertaken as part of this limited visual review. Vinyl siding will fade over the years and when replacing pieces it may be difficult to match the faded color. This component does not include the recent walkway ceiling replacement project. Those ceiling areas are protected from the elements and should have a long useful life. Repair the ceiling areas as needed. Possible funding could be required in future reserve studies. Best to reevaluate at a later date. The useful life expectancy shown below is for financial planning purposes. Evaluate the siding, and the critical underlying waterproofing (building paper or house wrap) as the remaining useful life approaches zero years. Adjust remaining useful life as dictated by the evaluation of performance of the underlying waterproofing. Cost estimates shown here assume that siding will be replaced with a similar vinyl material again; if other siding types are considered for replacement, the Reserve Study should be updated accordingly to incorporate new estimates.

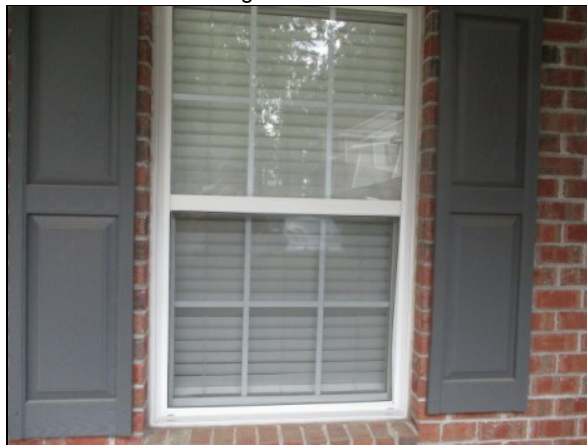
Comp #: 2363 Unit Windows & Doors - Replace

Comments: No leaking reported. Based on limited review of the Association's governing documents, individual owners are believed to be responsible for window and door replacement at their units. However, our review is not intended to be a professional legal opinion and we reserve the right to revise this component if the Association is otherwise found to be responsible for replacement. No recommendation for Reserve funding at this time.

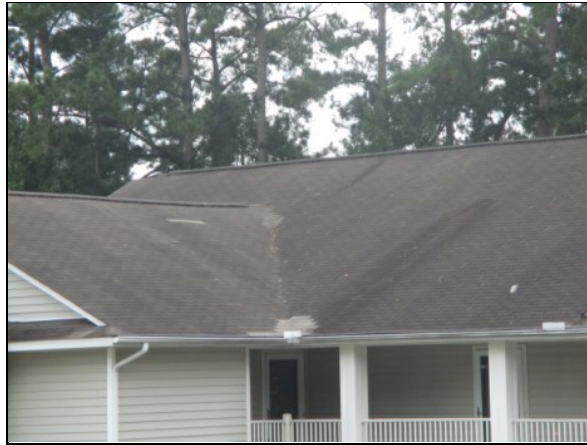
Comp #: 2381 Roof Phase 1 (Comp Shingle)-Replace

Comments: Asphalt shingle roofs determined to be in poor condition typically exhibit noticeable curling/lifting at edges, as well as moderate loss of granule cover. Presence of organic growth may also be a factor for aesthetic reasons. At this stage, frequency and severity of leaks tends to increase, which can cause damage to underling structure if not addressed. Dimensional shingles typically have longer useful lives and are generally considered to be more valuable from an aesthetic standpoint. We recommend budgeting to replace with dimensional shingles upon failure. Also known as architectural shingles, these types of roofs are typically more durable and wind-resistant than 3-tab shingles. Unless otherwise noted, costs shown here assume that only a minimal amount of substrate/decking repairs or replacement will be required. For very old roofs or those with significant leak problems, additional repair costs may be incurred. As routine maintenance, many manufacturers recommend inspections at least twice annually and after large storm events. Promptly replace any damaged/missing sections or conduct any other repair needed to ensure waterproof integrity of roof. Keep roof surface, gutters and downspouts clear and free of moss or debris. Moss growth can decrease the life of the roofing shingles and should be removed promptly. We recommend having roof inspected in greater detail (including conditions of sub-surface materials) by an independent roofing consultant prior to replacement. There is a wealth of information available through organizations such as the Roof Consultant Institute <http://www.rci-online.org/> and the National Roofing Contractors Association (NRCA) <http://www.nrca.net/>. If the roof has a warranty, be sure to review terms and conduct proper inspections/repairs as needed to keep warranty in force.

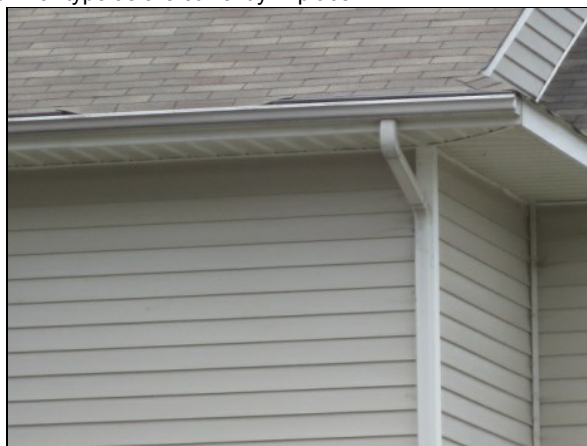
Comp #: 2387 Gutters/Dspts - Replace

Comments: No issues reported or noticed. Gutters and downspouts are assumed to be functioning properly unless otherwise noted. As routine maintenance, inspect regularly, keep gutters and downspouts free of debris. If buildings are located near trees, keep trees trimmed back to avoid accumulation of leaves on the roof surface which will accumulate in the gutters and increase maintenance requirements while reducing life expectancy. Repair or replace individual sections as needed as an Operating expense. We generally recommend that the gutters and downspouts be replaced when the roof is being resurfaced/replaced. National Roofing Contractor Association (NRCA) roofing standard includes installing eave flashings at the gutters. We suggest to plan for total replacement of gutter and downspouts at the same intervals as roof replacement for cost efficiency. Costs shown here assume replacement with similar type as are currently in place.
